# Guidance for Inspecting Closed, Illegal, and Abandoned Disposal Sites for State Minimum Standards

## DRAFT

**January 7, 2002**

Prepared By:  
California Integrated Waste Management Board  
P.O. Box 4025  
(1001 "I" Street)  
Sacramento, California 95812-4025

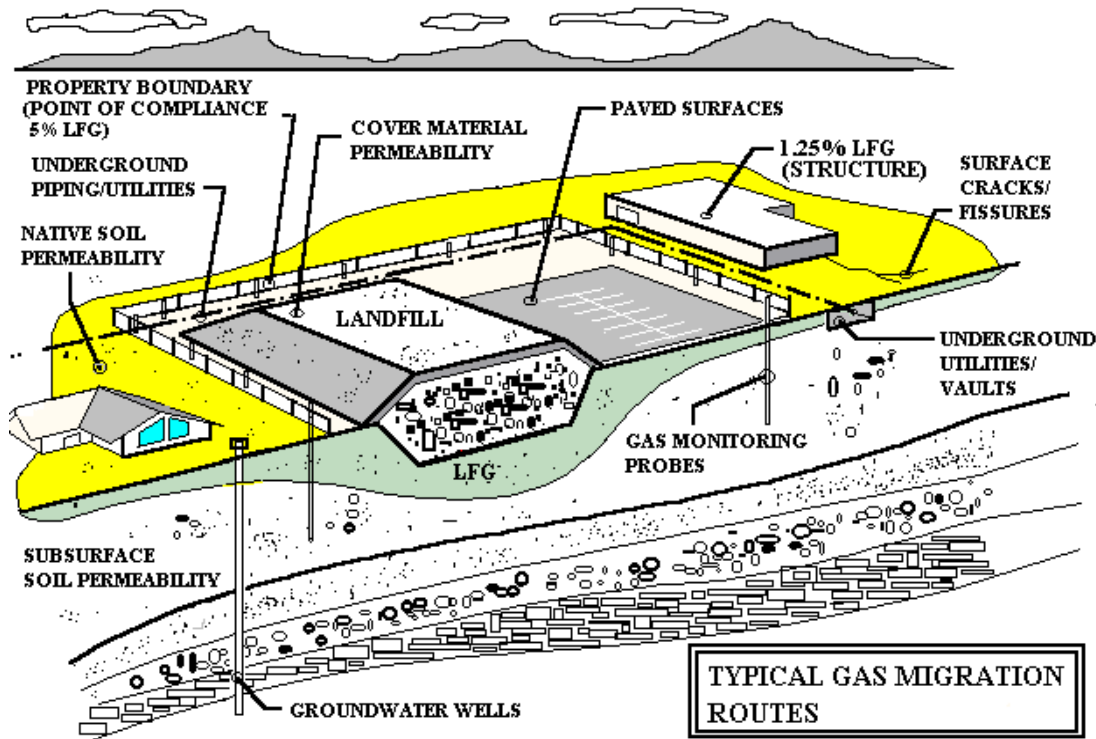
Figure 1. Typical Gas Migration Routes from a Disposal Site

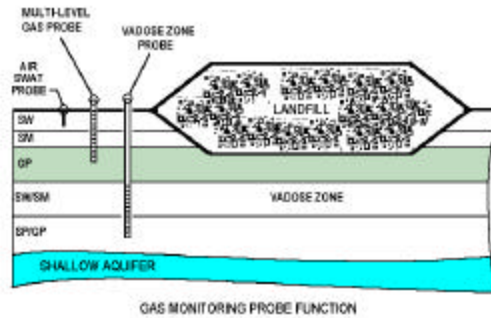
Figure 2. Air SWAT Probe shown relative to 27 CCR Probe

- 1) An adequate (and LEA approved) gas monitoring network is in place (27 CCR specified monitoring probes, probes consider structures, receptors, geology, etc.). SWAT probe data is suspect (Figure 2) since the methodology for placing SWAT probes was to drive a 6-ft long steel pipe containing a small sampling hole in it's tip into the ground. An acceptable gas monitoring probe (Figure 3) is a multi-depth probe placed in native soil adjacent to fill areas, bored to the depth of the landfill, completed using the maximum amount of screen possible, sealed between probe depths with a minimum two foot bentonite seal, annular spaced packed with 3/8 inch pea gravel and finished with labcock valves with labeling tags and a traffic-rated locking vault.

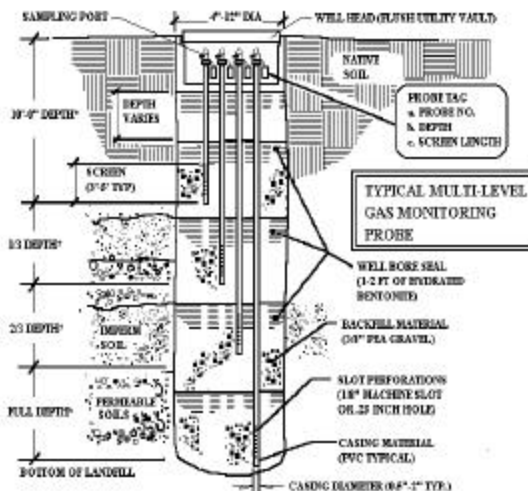
Figure 3. 27 CCR Gas Monitoring Probe Construction

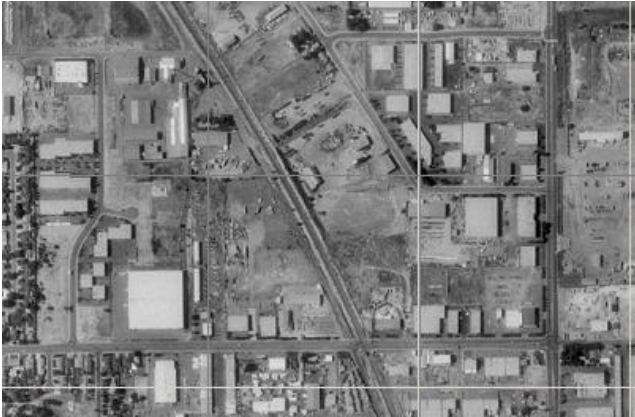
**Figure 4. Aerial Photo of 14<sup>th</sup> Avenue Landfill , Showing commercial Subdivision, Sacramento CA**

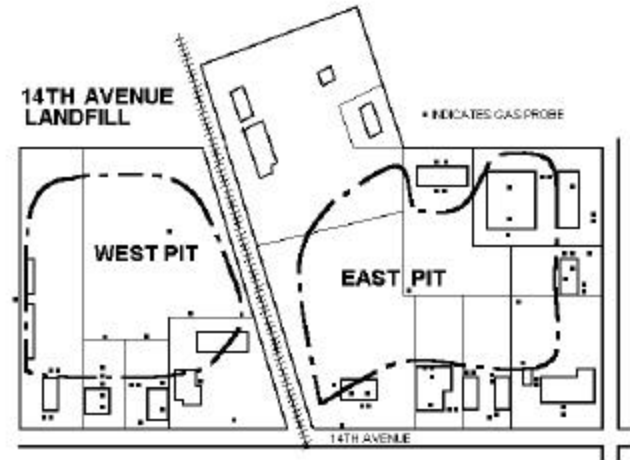
**Figure 5. 14<sup>th</sup> Ave Landfill Boundary**

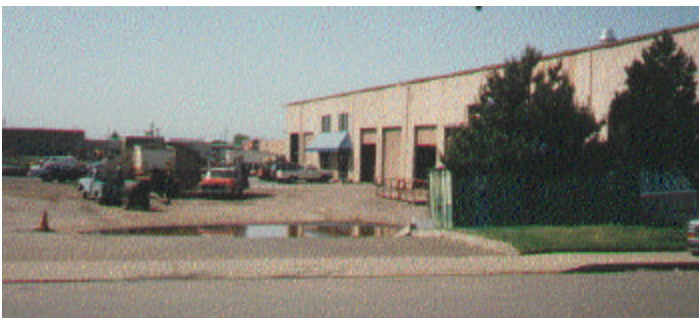
**Figure 6. Differential Settlement Damage to Structures**

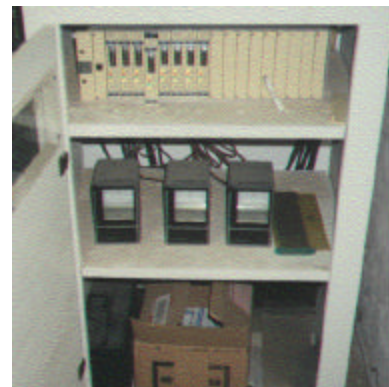
**Figure 7. Structural Gas Monitoring**

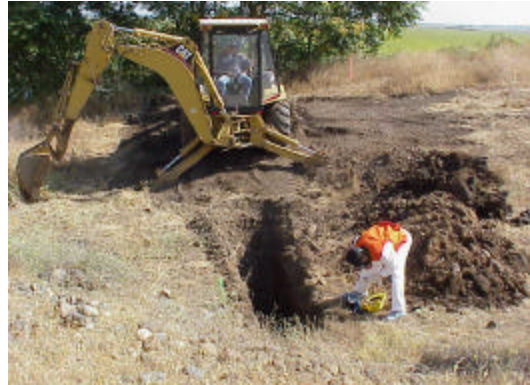
**Figure 8. Investigating Cover Thickness At Noah Webster Elementary Burn Site**

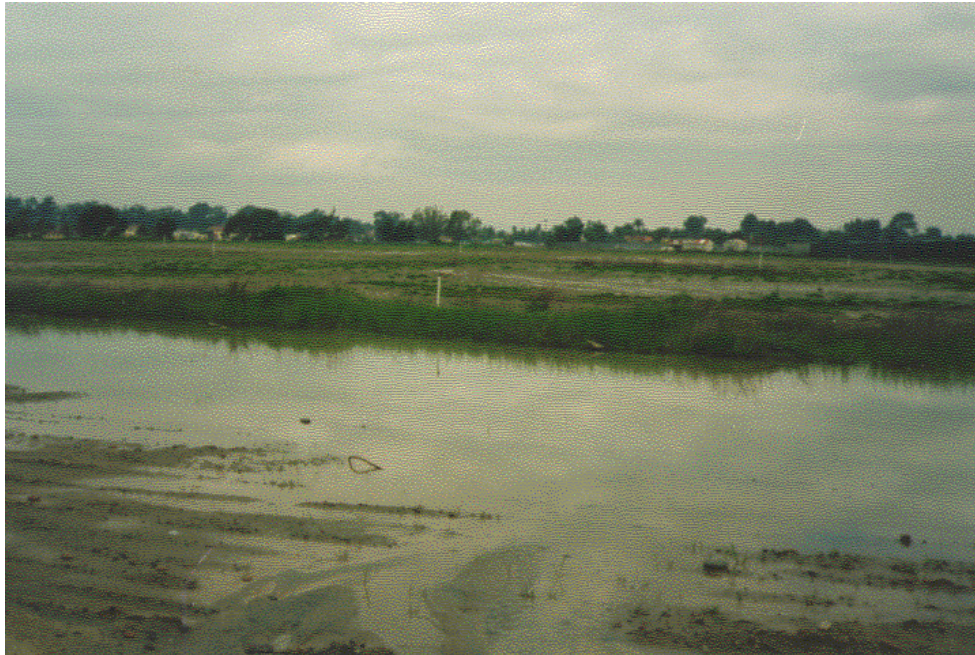
**Figure 14. Ponding on Landfill Surface at the Former San Diego Naval Training Center Landfill**

- ❑ Ponded water on flat deck areas (differential settlement could cause)—note that at flat sites grades are difficult to "build-up" and a significant amount of import soil may be required, e.g. a 3% slope requires 3 feet of relief for every 100 horizontal feet.
- ❑ Signs of cover erosion from overland flow, e.g. "erosion rilling"
- ❑ Drainage causing erosion of cover
- ❑ Drainage carrying trash or leachate from landfill to nearby surface water
- ❑ Drainage confluences causing damage to disposal site cover.)

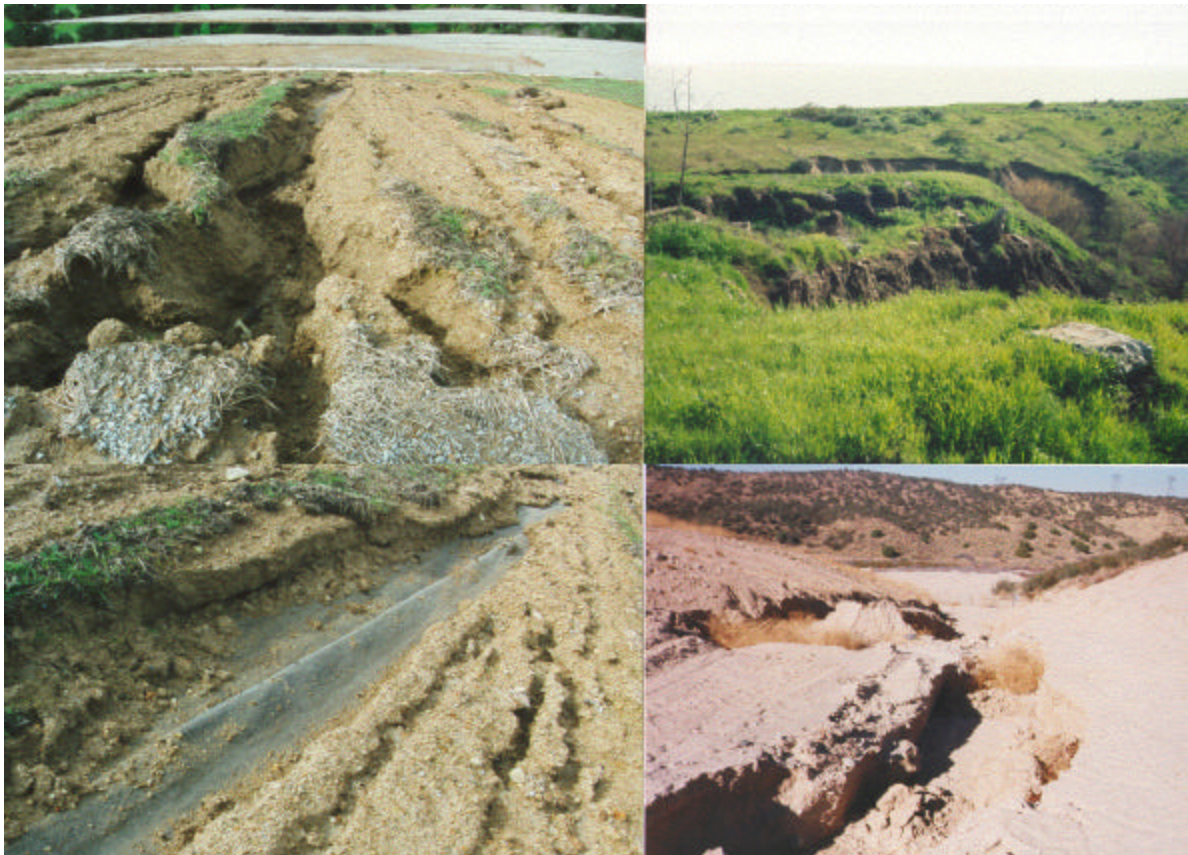
**Figure 13. Examples of Erosion Damage.** 1) Slope Erosion Rills at Cold Canyon Landfill due to erodible soil, lack of vegetative cover, control of run-on to slope, 2) Massive slope erosion at the Cactus Road Autoshrredder Disposal Site due to erodible soils, large watershed confluence area, high run-off velocity, oversteepened waste slope, 3) Erosion damage near the Hesperia Landfill due to large drainage confluence area and erodible soils.

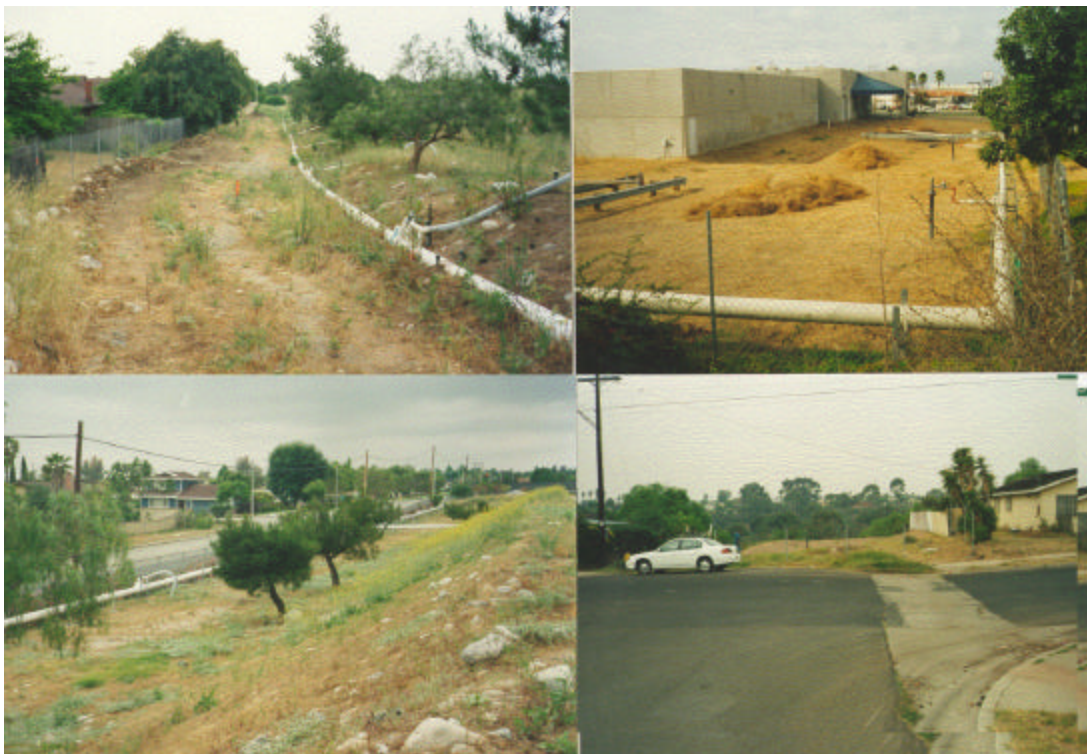
**Figure 15. Examples of Adjacent Land-Use and Site Access Security Issues. 1&3) Upland Landfill in San Bernardino County, surrounded by residential housing on 3 sides; gas control system highly visible, 2) Duckpond Landfill in National City located in a commercial district (auto dealers); National City Blvd adjacent to site, 4) 38<sup>th</sup> and Quince Burn Site in San Diego, is actually a Lot Parcel in the middle of a residential neighborhood.**
